# STOW POLICE DEPARTMENT

PRIVATE PROPERTY ACCIDENT REPORT/MINOR  
TRAFFIC ACCIDENT REPORT

26-06567

4460 Hudson Dr. Stow, OH 44224 (Hallstar Company)

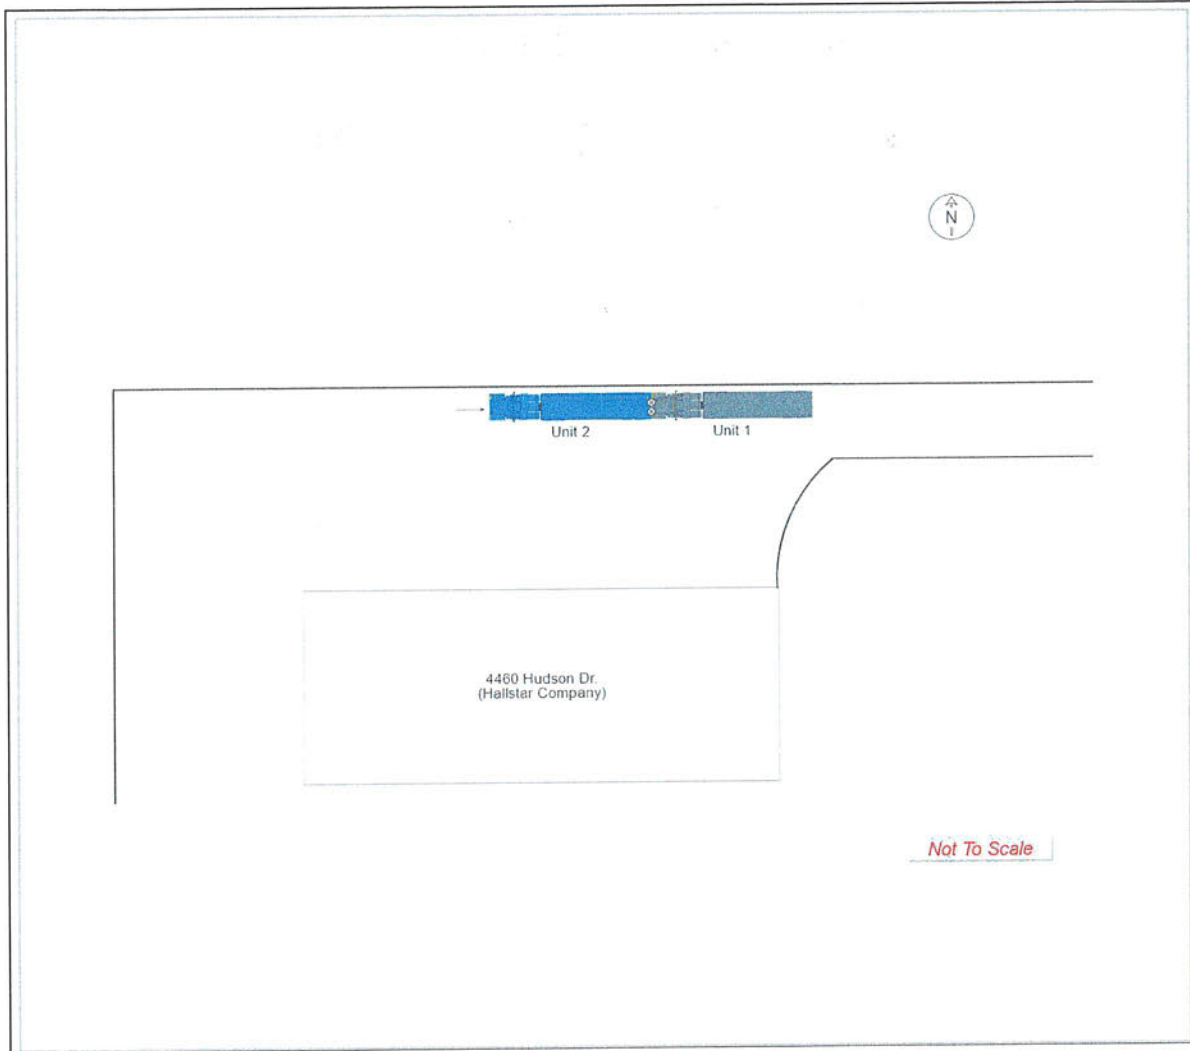
## FIELD SKETCH (not drawn to scale)

Unit 1 was stopped behind Unit 2 in the parking lot of 4460 Hudson Dr. Both trucks were facing west. An employee from the business instructed Unit 2 to pull into a loading dock. Unit 2 began backing, from west to east, before it was safe to do so, striking Unit 1 in the front.
