STOW POLICE DEPARTMENT

PRIVATE PROPERTY ACCIDENT REPORT/MINOR
TRAFFIC ACCIDENT REPORT

INCIDENT NUMBER
22-03257

Private Property Private Property - Hit/Skip Minor Traffic Accident

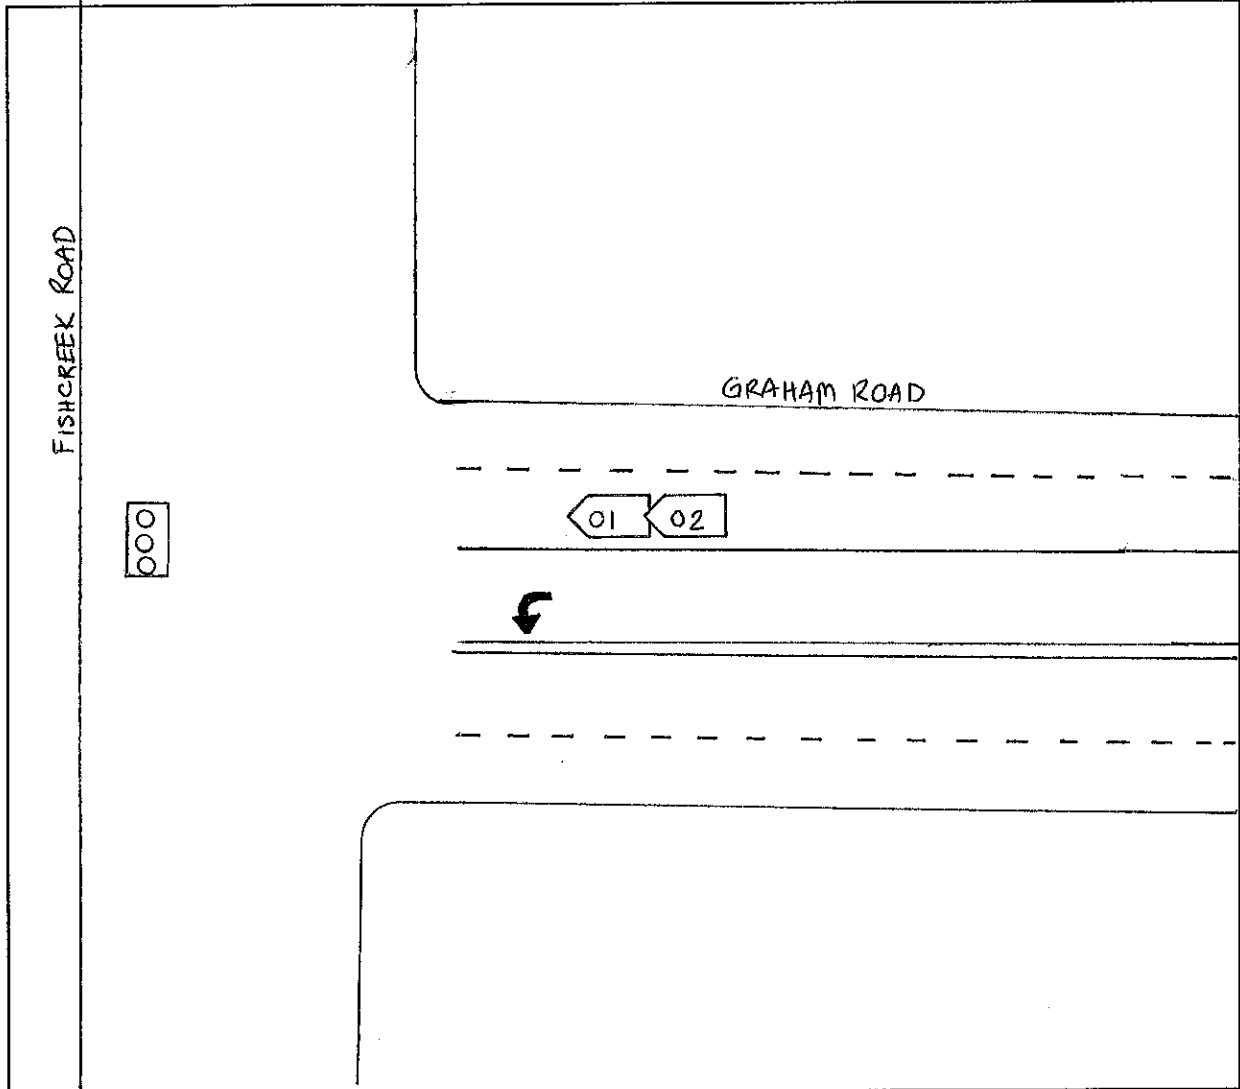
FIELD SKETCH (not drawn to scale)

Unit 01 was traveling westbound on Graham Rd, stopped at a red light at the intersection of Fishcreek Rd in the middle lane. Unit 02 was stopped directly behind Unit 01. Unit 02 stated she thought the light had turned green and began to drive, however it was still red. Unit 02 failed to maintain assured clear distance ahead and struck Unit 01. Unit 02 did not believe she struck Unit 01, however Unit 01 stated they felt the impact, which was slow-moving. Unit 01 did have minor damage to the rear bumper which appeared to be from the bolt of Unit 01's front license plate. Pictures of the damage obtained and placed in the digital media file.
